**DEPARTMENT OF TRANSPORTATION****DIVISION OF ENGINEERING SERVICES**

Contract #: 04-0120F4Cty: SF/ALA Rte: 80 PM: 13.2/13.9File #: 69.15**SOURCE INSPECTION REPORT****Resident Engineer:**Pursell, Gary**Address:** 333 Burma Road**City:** Oakland, CA 94607**Report No:** SIR-000737**Date Inspected:** 05-Jul-2009**Project Name:** SAS Superstructure**OSM Arrival Time:** 0**Prime Contractor:** American Bridge/Fluor Enterprises, a JV**OSM Departure Time:** 12**Contractor:** Zhenhua Port Machinery Company, Ltd (ZPMC), Changxing Island **Location:** Changxing Dao, Shanghai

## SOURCE INSPECTION REPORT

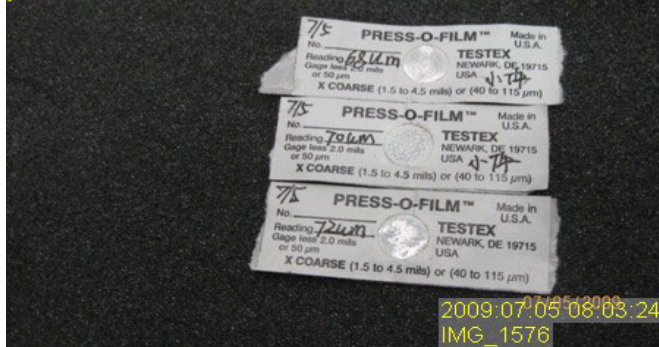
that the base metal on several of the items did not meet the Society for Protective Coatings (SSPC) SP10 Near White Metal Contract requirements. ZPMC was informed by ABF QC that further grinding and abrasive blasting was required. ABF QC's determination was verified by Caltrans QA Coatings Inspector Jordan. The contractor began performing the repairs as directed by ABF QC personnel. After the inspection was completed the items that were determined to successfully meet the SSPC SP10 Near White Metal Contract requirements were transported to the paint shop area and spread out for primer application. Residual Chlorides (soluble salts) tests were performed on the abrasive blasted surfaces. The Bresle Patch method was used to test for Residual Chlorides. The test results showed that the surface was acceptable to be coated with Interzinc 22. The highest registered reading of salts contamination was 10 microsiemens per square centimeter which is below the contract maximum of 10 micrograms per square centimeter (92.5 microsiemens per square centimeter). Ambient conditions were within Contract required parameters. Surface profile Testex Tape was used by ZPMC QC personnel to record the blast profile. The Testex tape was measured using a dial micrometer. The micrometer readings of the Testex Tape were within the contract requirements of 40 and 86 microns. Ambient conditions were within Contract required parameters. The surfaces to be coated were blown down again with compressed air to remove dust. After the dust was removed, Interzinc 22 primer was applied within the specified 8 hour window after the start of abrasive blasting. The coating was mixed under the supervision of International Paint's Onsite Technical Services Representative, QC personnel representing ABF and ZPMC.

OBG Miscellaneous Metal: Testex tape abrasive blast profile readings from splice plates.

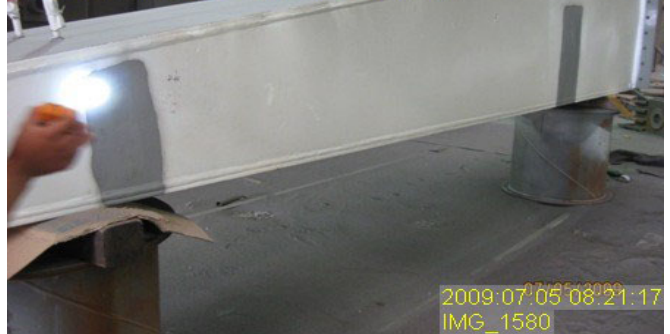
Caltrans QA Coatings Inspectors received Notices of Inspection to attend joint inspections with ABF and ZPMC QC for surface preparation by abrasive blasting and primer coat application on 7 bike path components. Areas that sustained welding and cutting damage during fabrication after finish coating were abrasive blast repaired. After the inspection was completed the surfaces were determined to successfully meet the SSPC SP10 Near White Metal Contract requirements. Residual Chlorides (soluble salts) tests were performed on the abrasive blasted surfaces. The Bresle Patch method was used to test for Residual Chlorides. The test results showed that the surface was acceptable to be coated with Interzinc 22. The highest registered reading of salts contamination was 10 microsiemens per square centimeter which is below the contract maximum of 10 micrograms per square centimeter (92.5 microsiemens per square centimeter). Ambient conditions were within Contract required parameters. Surface profile Testex Tape was used by ZPMC QC personnel to record the blast profile. The Testex tape was measured using a dial micrometer. The micrometer readings of the Testex Tape were within the contract requirements of 40 and 86 microns. Ambient conditions were within Contract required parameters. The surfaces to be coated were blown down again with compressed air to remove dust. After the dust was removed, Interzinc 22 primer was applied within the specified 8 hour window after the start of abrasive blasting. The coating was mixed under the supervision of International Paint's Onsite Technical Services Representative, QC personnel representing ABF and ZPMC.

OBG bike path: abrasive blast repairs to damaged coating during fabrication trial assembly after finish coating.
